# VW A1/A2/A3 Shift Linkage Installation

## A1/A2/A3 Transmission/Shift Linkage Kits:

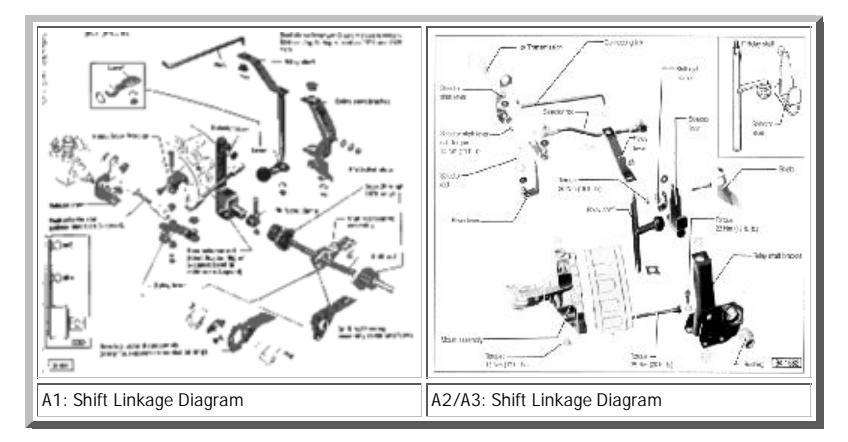
If you look closely at the water-cooled VW shift linkage, its truly a marvel of mechanical design. It transmits the front-back and side-side motion of the shift lever on the floor of the vehicle into motion on selector shaft of the transmission, to allow shifting gears. Front-back motion of the gear shift is transferred as back-front motion of the shift rod which in turn is translated into left-right rotation of the relay shaft which in turn is translated into a rotation of the selector shaft. Side-side motion of the gear shift is converted to rotation of the shift rod, which is converted to a left-right motion of the rear selector rod then to a front-back motion of the front selector rod which pushes and pulls on the selector shaft of the transmission. Click on the image(s) below for a detailed view of a typical A1 or A2/A3 shift linkage:

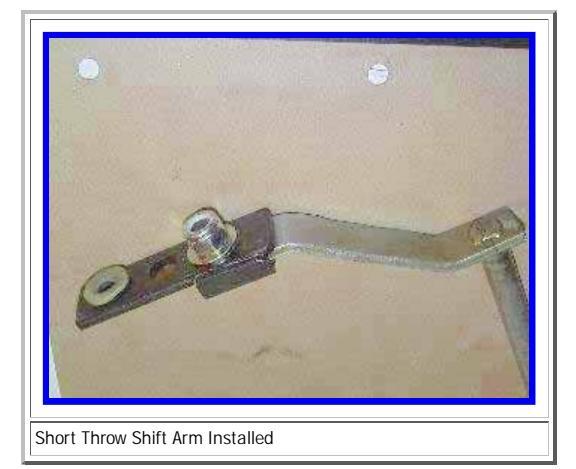
- · Set the parking brake and place the transmission in neutral, open the hood
- · You may want to remove the relay shaft for ease of installation
  - A1: Remove the nut that retains the shift ball at the base and the or the clip that retains the shift rod at the top (needed if replacing the pivot bushings), or just do the upgrade on the lever in place

- A2/A3: Remove the nut at the top of the relay shaft that holds the shift arm in place
- · Remove the bushing that the shift rod inserts into
  - If the bushing is hardened from age, try soaking it in very hot, soapy water to soften and lubricate it

- Use a flat bladed screwdriver to press in at the base of the small end of the bushing to collapse it and push it through the hole
  - If all else fails, you can cut off the small end and press it out of the hole

- If not installing a complete Missing LinkZ kit, then it would be necessary to replace the bushing
- · Place the extension on top of the lever and the clamp on the bottom

- Tighten the retaining nut and torque it down to approx. 20-30 ft-lbs to securely clamp the extension to the lever
- · Make sure there is no side to side play in the extension, if so, tighten it further • Re-install the bushing at the inner hole for a ~25% reduction or the outer hole for a ~50% reduction, insert the rod and insert the retaining clip

- 1. There is supposed to be some room around the stud welded into the U-shaped clamp and the hole in the relay shaft arm, the stud is 7/16" (11mm) and the hole is 9/16" (14mm).
- 2. The U-shaped clamp is supposed to be a tight fit over the relay shaft arm. In fact it should spread out a bit as you tighten down the not on the stud.
- 3. Its the U-shaped clamp that fits around the sides of the relay shaft arm and the short throw extension that hold the two together. The nut and stud simply hold the clamp in place
- If you removed the relay shaft to install the short throw arm, be sure to properly tighten the nut holding the relay shaft in place, perhaps even use some thread locking 4 compound.

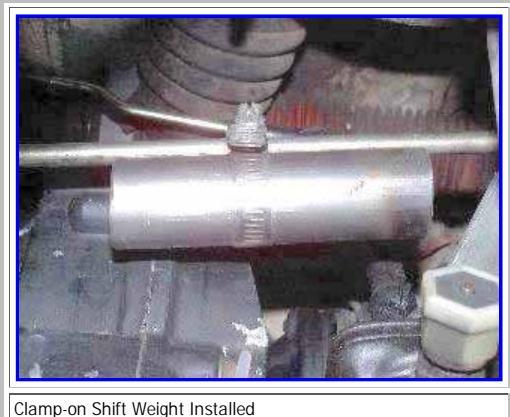
· Set the parking brake and place the transmission in neutral, open the hood

- Open up the hose clamp so that you can fit it around the shift rod (alternately, you could pop one of the shift rod ends loose)
- Place the groove in the weight along the shift rod and slide the clamp over the weight, roughly in the center
- Tighten the hose clamp down and check for clearance by manually shifting the linkage into all the gears
- You may want to run a bead of sealant along the groove in the rod to held hold it in place if the clamp loosens up
- · Lower the hood and give it a test drive, it may take a few days to adapt to the new and improved feel of the shifter

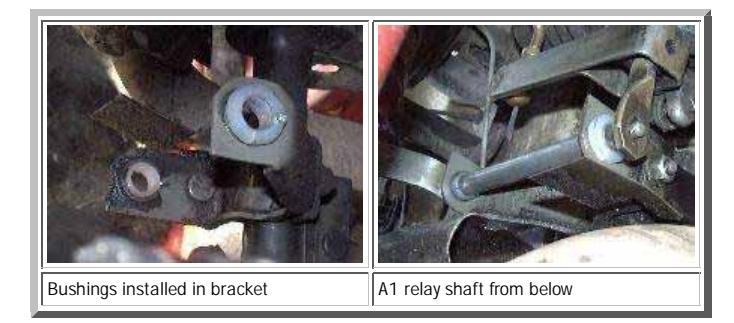
Pictured above is new bushings installed in an A1 relay shaft bracket, on the left is from the top looking down, on the right is from below looking up.

- 1. Since the bushing material is rigid, you can't "squeeze" it into the bracket hole like the OEM polyurethane version. Instead, the bushing it turned to the exact size of the hole. If you find it too difficult to press it in place, a radial slit can be cut in it to allow it to be compressed a bit to fit into the hole. When the relay shaft is inserted, it'll expand and lock into place in the bracket.
  - Likewise, if you find the bushing fits your shaft a little too loosely, you can also cut a fine slit in it like pictured and then wrap the outside of the bushing in some good quality elecctrical tape or a wrap of fine guage wire to close the slit tighter. You do not want the bushing so tight that the relay shaft binds up and is not free to rotate.
- 2. A small screw serves to keep the bushing stationary in the bracket while the shaft rotates in the bushing.

We have observed minor variations in relay shaft diameters, some are 14mm, some aftermarket ones are 9/16" and they can vary between A1 and A2/A3 vehicles. So, we drill the center hole in the bushing to fit properly on the smallest OD shaft we've found. If it feels a bit tight on another shaft, it is a simple matter to use a file or a roll of sandpaper to slightly enlarge the bushing to fit properly. We also find that an application of a graphite or moly grease to the inside of the bushing helps both installation and initial operation.

While taking the above pictures, I removed my year old UHMW bushings and once cleaned of oil and grease (my engine has an oil leak and I just had an inner CV explode) they could pass for brand new. No discernable wear or play in the bushings. Only reason I removed them was to test the new Teflon bushings. I did notice a small difference in feel between the UHMW and Teflon, with the Teflon giving a bit lighter *feel* to the shift. I also did not need to apply any grease on the Teflon bushings like I did with the UHMW. But if you want to add grease or other lubricant, feel free. What kind? Anything you want to or have on hand. Both UHMW and Teflon materials are pretty much inert to most lubricants and solvents. Only items to avoid are things like benzene, ether, methyl ethyl ketone, etc.

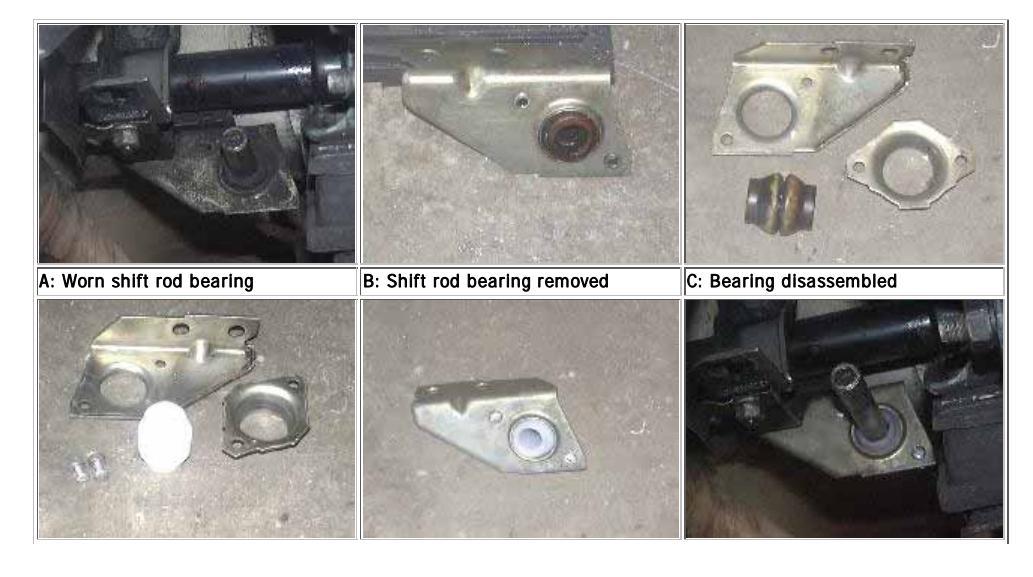
D: New shift rod bearing E: New bearing assembled F: New bearing installed

In the A1 chassis, there is one bushing that is located inside a steel bracket called the shift rod bearing. It is not designed for replacement without replacing the entire metal bracket, at least until now!

- If the shift rod bearing is too tight inside the bracket, you can slightly loosen the screws holding the two halves together. A thin washer can also be inserted in between the bracket halves.
- If the shift rod bearing has a little too much play inside the bracket (usually due to rust or corrosion of the bracket body), a 1" ID, 1/16" dia. rubber o-ring can be slipped over the bearing before slipping it between the bracket ha;ves. The o-ring will fill up the space inside the bracket. Alternately, a silicone or butyl rubber sealant could be applied to the inside of the bracket to hold the bearing mor snugly once the sealant cures. The sealant will provide the compliance needed to allow the bearing to move inside the bracket, which it needs to do work properly.

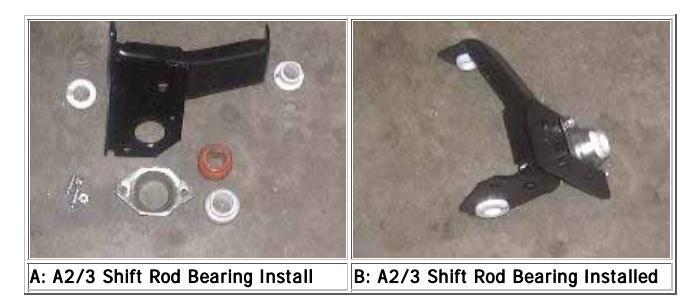
For the A2/A3 chassis, the shift rod bearing is located in the relay shaft "tower". It is easiest to remove it from the vehicle and repair it on the bench:

To install the new bushing, the old bushing and bracket must be removed from the vehicle. Assuming the selector lever has been unclamped and removed (be sure to mark it for ease of later installation and shift linkage alignment) from the shift rod (image A), remove the pair of 13mm nuts that hold the bracket to the steering rack bracket. Clean the bracket (image B), drill (7/32" or 5.5 - 6mm bit) or punch out the 2 rivets that hold the bracket together (image C). Then install the new bushing (image D) and screw the bracket back together with the supplied screws (image E) and then install the refurbished shift rod bearing into place. The shift linkage will then need to aligned as discussed elsewhere in this document.

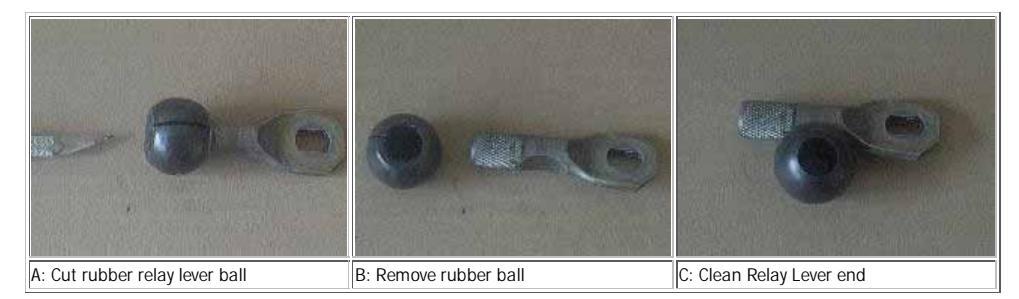
Remove the existing relay lever from the bottom of the relay shaft. Easiest to access from beneath the vehicle. Typically held in place with a 13mm nut and lock washer (save for later reuse). With the relay lever removed from the vehicle, you may need to slit the remnants of the rubber ball end with a utility knife (photo A, below). To ease cutting you can dip the blade in water or light lubricating oil. Usually you'll need to make a few passes to slice down to the center of the ball. Once slit to the center, peel the rubber ball off the end of the lever (photo B, below). You'll probably find that there is a layer of rubber suck to the knurled end of the relay lever. The easiest way to remove that is to heat up the relay lever end with a heat gun or propane torch, to the point the rubber just starts to smoke. Then, hold the lever in a vise or pair of pliers (it may be hot) and use a cloth rag to twist the rubber off the end of the lever, it should come off fairly easy. If some remains, reapply the heat the wipe again. The cleaned lever end should look like the one in photo C, below.

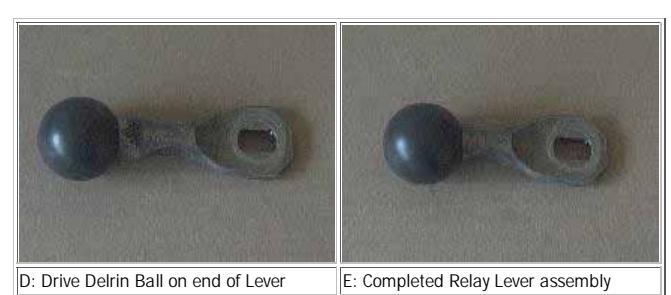
Then, place the hole in the Delrin ball over the end of the relay lever and press it onto the knurled end until it bottoms out. It is a tight fit. You can use a rubber mallet or dead blow hammer to do this, or place the ball onto a piece of wood and use a hammer to drive the lever into the ball. The finished assembly is shown in photo E, below. If you find your relay lever end is worn to make the fit of the ball loose, feel free to use a good grade of high temperature epoxy glue on the end before pressing the ball in place.

Once complete, re-install the relay lever on the bottom of the relay shaft. Torque the nut to the value specified in the Bentley repair manual, approx. 15 ft.lbs. You may want to check that nut for tightness after a few hundred miles of driving.

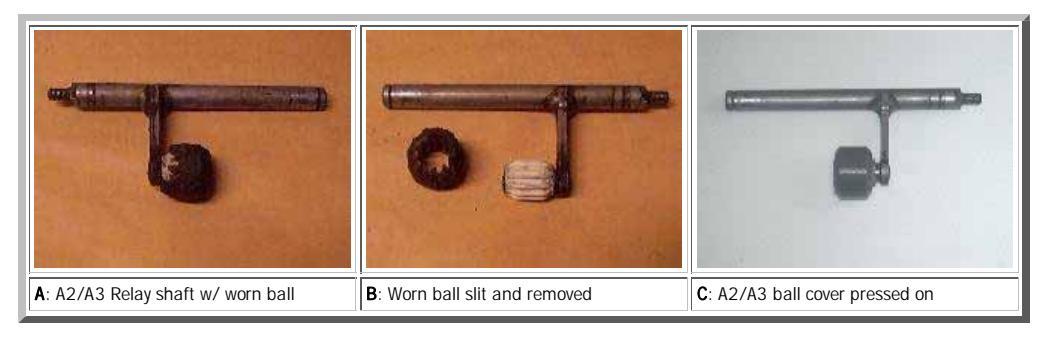
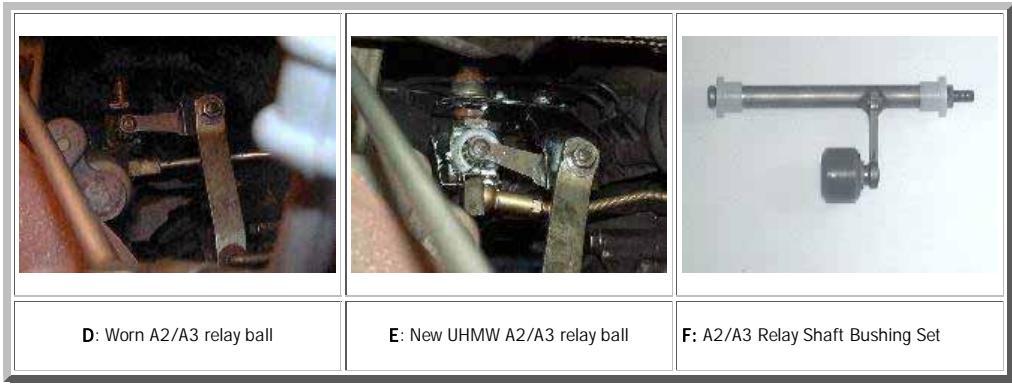
Note that the current ball cover color is gray, although this can change back to white depending on material availability. Both the gray and white covers are equally functional, tehy install the same way and work alike.

- To install the new bushing, the relay shaft should be removed.
  - See photo D above for the pre-installation.
  - There is a small spring clip at the bottom of the relay shaft that can be pried off with a small flat bladed screwdriver, this is most easily accessed under the vehicle.

- You can now lift the relay shaft straight up and out of the relay shaft bracket, see photo A above.
- The old ball material must be removed from the nylon core (if any is present).

- The flexible outer layer can easily be peeled back and removed, see photo B above.
  - Clean up the relay shaft then press the new UHMW-PE bushing over the nylon core until its fully seated, see photo C above.

- Push on the lower clip from underneath the vehicle.
  - Install the arm on top of the relay shaft and tighten down the nut.
  - See photo E above for the completed assembly.

- Photo F shows the placement of the new bushings on the A2/A3 relay shaft.
- Although the UHMW material is self-lubricating, you can apply a coating of any type of grease to the ball if you wish, to help smooth out the shifting operation.

- The ORANGE shift rod bearing pictured in "E" above, is not included in the shift linkage kit. If this part is worn, a new part can be obtained here.
- If your relay shaft ball is worn to the point that the inner nylon core is chewed up, I can custom drill in inside of the bushing to fit a smaller than normal (21.5mm) core. The replacement "ball cover" relies on a tight press fit for installation.
- IMPORTANT: If the inner nylon core is loose enough to slip off the pivot stud on the relay shaft (picture G below), you can use a hammer to peen over the end of the stud (to flare or mushroom it out) to hold the core in place (picture H below). Just place the base of the stud on a solid surface and work your way around the edge of the stud with the hammer to bend (or peen) it over to create a lip to keep the core from slipping off.

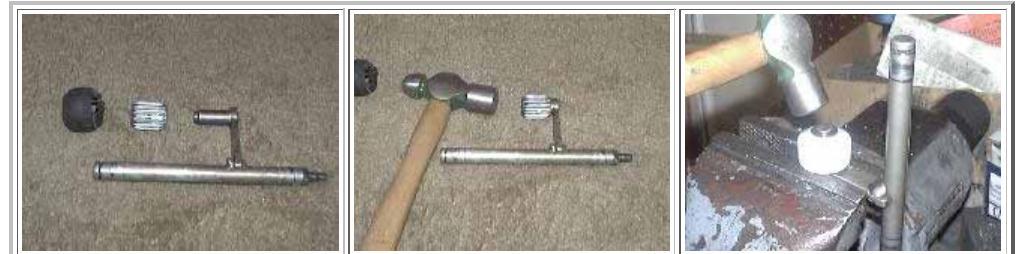
G: Loose relay shaft ball core	H: Peening the end of the stud	I: One piece ball replacement
· · · · · · · · · · · · · · · · · · ·

• If the inner nylon core is so badly worn or even missing, a complete replacement ball is available (picture I), it slips over the stud on the relay shaft, then a small washer goes over the end before peening the end of the rod over to lock the washer in place. The full ball replacement kit runs \$25 for the solid UHMW ball and retaining washer.

Then, re-install the relay shaft and check the fit and operation. If you find the ball/cage fit is too loose, you can bend the sides of the cage in a little bit or if the fit is too tight, they can be bent outward a little bit as needed. You want to make sure there is no binding of the relay shaft as it swings about the vertical axis.

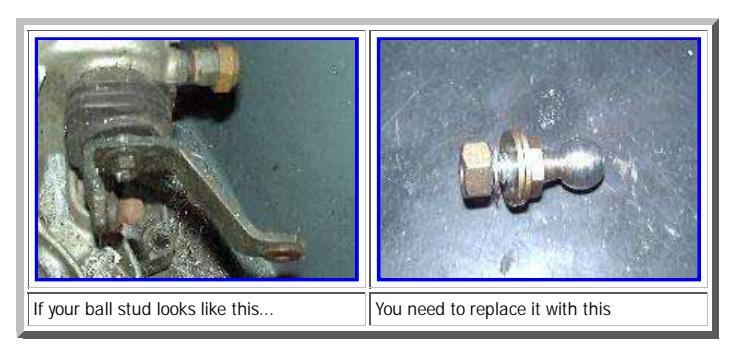
VW uses 13mm ball studs for ends on two of the shift linkage components. Over time and due to lack of lubrication, these ball studs can become corroded and/or worn.

To replace the ball stud, you must remove the affected linkage end, drill out the pressed in ball stud base (5/16" drill bit), then use a punch to drive out the old ball stud. Then using the 5/16" bit, ream out the hole for the new stud. Insert the stud and lock washer, tighten down the nut (you can also use a thread lock compound as well) and re-install the linkage end on the transmission. Don't forget to lubricate the socket with some grease before installing the socket. Below is how I rebuilt my transaxle selector shaft:

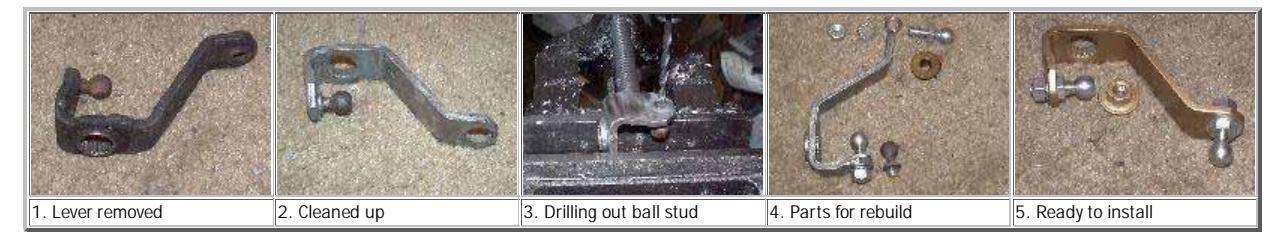
You can follow the steps above (holding cursor over each image will pop up a description of the procedure). Note that in images 4 and 5 (above) I pictured the selector lever with the ball stud for the Missing LinkZ shift linkage kit. Ball stud replacement doesn't require the Missing LinkZ to be used and rest assured that if you do order the Missing LinkZ linkage, the ball studs required for the basic installation are included. If you have some exiting studs that are worn, then order the replacements.

To reinstall the lever on the transaxle, it should be pointing straight up when the shaft is in the middle position. The teeth on the splines are fairly coarse so its not hard to find the correct orientation. While I've illustrated the procedure for rebuilding the selector shaft, the procedure would be the same for the ball studs on the relay lever or selector lever. Mine were in good condition, so I only replaced the worn one on the selector shaft.

Be sure to fully tighten the nut on the bottom of the ball stud to seat the washer. Use a wrench on top of the stud and a wrench below, apply approx. 15 ft.lbs. torque. For added security, use a drop of red Loctite on the threaded end of the stud to help keep the nut fixed in place.

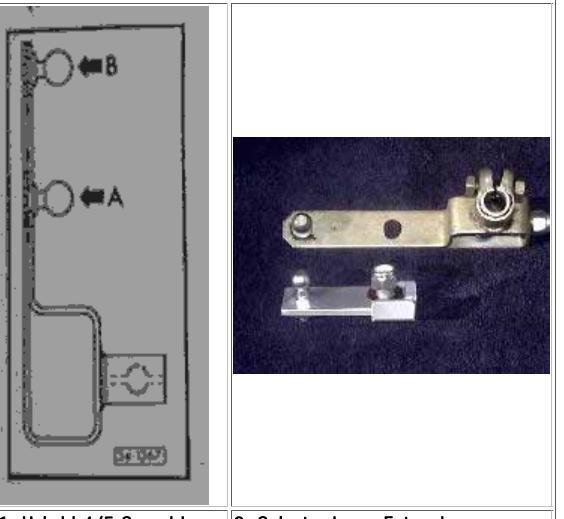
1: Hybrid 4/5 Speed Lever 2: Selecter Lever Extension

In photo 1 above, you can see a sort of hybrid 4/5 speed selector lever as shown in the Bentley Repair Manual. I don't know if such a part ever existed, but the "A" ball stud shows where the 4-speed linkage attaches, while the "B" ball shows where the 5-speed linkage attaches. So to convert a standard 4-speed selector lever to the longer 5-speed part, you basically need to extend the lever to move the "A" ball stud up to the "B" location. In photo 2 above, you can see the bolt on selector lever that does just this.

To install the selector lever extension, when converting a 4-speed shift linkage to the 5-speed version, you'll need to grind/drill out the ball stud in the selector lever. This is best done with the selector lever removed from the vehicle. The process is identical to the ball stud replacement above. If you opted for the larger diameter stud in the selector lever extension, you'll need to enlarge the hole left when you pressed out the ball stud. Likely you'll need to drill a 1/2" - 9/16" dia. hole in the end of the selector lever to allow room for the stud in the selector lever extension. For the smaller stud, you may need to enlarge the hole to approx. 3/8" to insert the stud. The hole will be about where the black dot is in the above image (this is of course a 5-speed selector lever) and in the real 4-speed selector lever, the lever arm would end just past the end of the ball stud which was in the hole you just drilled out. And of course, if you had the 5-speed selector lever, I would be happy to put it in place of the able image, but that is the best I have. If you have a better picture, send it along.

Once the stud in the extension clamp will fit over the end of the selector lever, you'll simply bolt on the extension arm in a fashion identical to installing the short throw arm. In the end, you'll end up extending the 4-speed lever from it's  $\sim$ 2" length up to the 5-speed length of  $\sim$ 4" from the center of the clamp to the center of the ball stud. You can see in the above photo how the stud of the clamp fits into the hole in the 4-speed selector lever, then it and the nut hold the extension past the end of the lever and places the ball stud at the same length as the 5-speed selector lever. This added length is what lets the shift linkage "reach" 5th gear, which is beyond the normal 1-2-3-4 pattern.

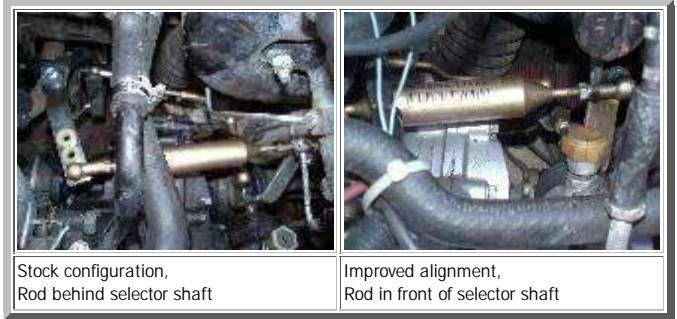
A key to proper shift linkage operation is alignment. This is especially important when changes are made to its geometry, such as using a shortened throw shift arm. In stock form, each link element was in direct alignment with its connecting element. As soon as an angle is placed in a link, instead of transferring 100% of the input motion to the output, you only transfer the cosine() of the angle of the link. This may not be directly apparent as "slop" but if you lose 5%-10% of the motion due to angularity, it doesn't matter where the motion was lost, its not helping the transmission shift gears. An example of correcting alignment is shown below:

By moving the weighted shift rod from the back of the selector lever to the front, it changes the angle from about 15-20° to near zero, which eliminates about a 5% angularity inefficiency. Alignment applies to the entire shift linkage system, starting at the shift lever all the way to the selector shaft on the transakle. You want the shift lever centered in its range of motion so that you'll have maximum travel in all directions. If its offset one way or the other, you'll be limited in that direction. In stock form, the only adjustment on the shift linkage is the location of the selector lever on the rod connected to the shift lever. Very small changes here have large changes in the linkage alignment. With a fully adjustable linkage, like the Missing LinkZ uses, you can make fine adjustments to each component independently to change alignment. If 1st and 2nd gear shifts are difficult, lengthen the rear selector rod as needed, etc.

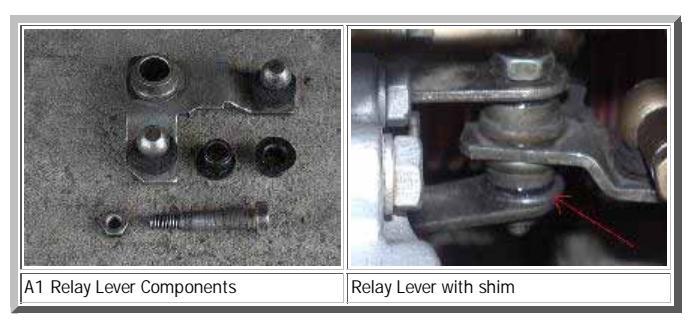
The relay lever is essentially a bell crank that converts east-west motion of the rear selector rod to north-south motion on the forward selector rod. When I had initially rebuilt my linkage with stock bushings, I had neglected this component, but it does have a pair of hard plastic bushings in it. I removed the nut and bolt that hold it in place and pulled it out for a look.

Instead of finding the bushings being worn (they were likely the 20 year old OEM bushings), I actually found that the length of the shoulder on the bolt was about 1 mm longer than the height of the lever and the bushings. Tightening the nut harder won't help as the shoulder on the bolt keeps it from getting any tighter. So instead, I took a flat washer and drilled it to fit over th shoulder and then installed the washer under the lever (see red arrow in photo above for location; with a little grease to let things move smoothly) and viola, the lever only rotates, no more racking, no more slop. And guess what, no need to push hard on the gear shift lever to get 1st gear and 2nd gear is no longer slow. If you need a washer set up for your A1 relay lever, I'll be happy to include one with your A1 linkage kit order.

If you find the relay lever gets too tight after installing the shim, just remove one or both of the plastic bushings and lightly sand down the flange end to shorten them a bit. Test fit and repeat until you get a nice smooth fit.
